# Rudder and Rudder Horn Repair on the Bulk Freighter Sophia D

By Uwe W. Aschemeier and Kevin S. Peters

On January 21, 2009 the 56,000 t Bulk Carrier Sophia D was in route to China, loaded with thousands of tons of iron ore. Off the coast of Brazil, the ship run on ground, damaging the rudder so severely that the vessel was dead in the water, unable to steer.

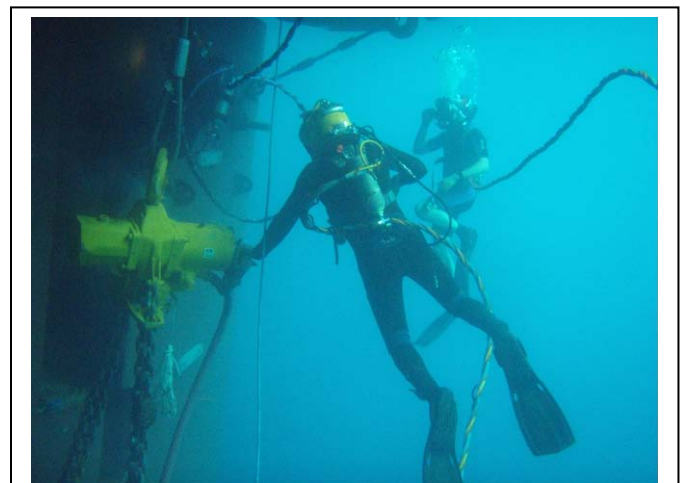
Diver operating a 25 ton air chain hoist during the removal of the rudder

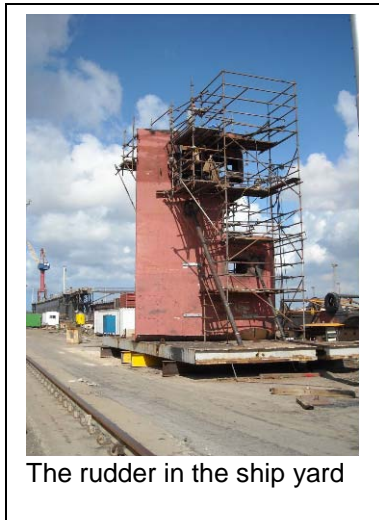
The inspection revealed severe damage to the rudder, which included the following:

- The upper and lower castings on rudder blade were misaligned
- The 1.75 inches thick rudder bottom plate was bent upwards up to an angle of 45°.
- The skin plates on the port and starboard side as well as the top plate were buckled.
- After the skin plates on the port and starboard side were cropped out to be renewed, internal plates were found to be buckled to a point that they needed to be cropped out and replaced.

The plate mounted to the bottom of the rudder (1 ¾ ") was bent so badly, it had to be trimmed approx. 1" overlapping the edge of the rudder skin, before the rudder could be re-installed onto the vessel. This plate will be replaced later in the ship yard. The purpose of this plate is to help with the steering of the vessel at slow speeds.

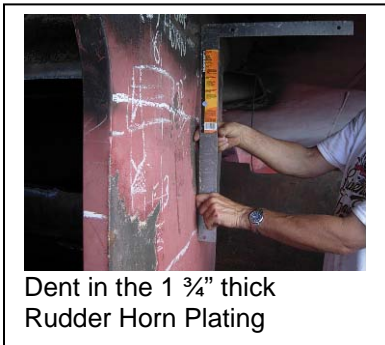
Since the rudder horn was bent 8 inch starboard, 2 inch aft, the horn was cut from the vessel at approximately 12 inch below the hull penetration, and an approximately 8 inch tall section was removed. During the cutting operation the lower, 25 ton portion of the horn was supported vertically by six 15 ton load rated turn buckles. For side alignment, four 10 ton chain hoists were placed fwd and aft at the port and star board side between the hull plating and the lower casting at an approximately 30° angle.

The rudder horn nose plate was found to be cracked and had to be copped out and replaced. The steel thickness for the rudder horn plating and the nose plate was 1 3/4".

The rough cut was ground smooth, and a 45 bevel was prepared at the upper part of the rudder horn plating. For the lower part of the joint, the 200 mm tall plate insert needed to be prepared with a 45 bevel.

An 8 inch tall plate insert was installed to remove the "dog leg" so that the pintle bushing could be realigned with the upper neck bushing.

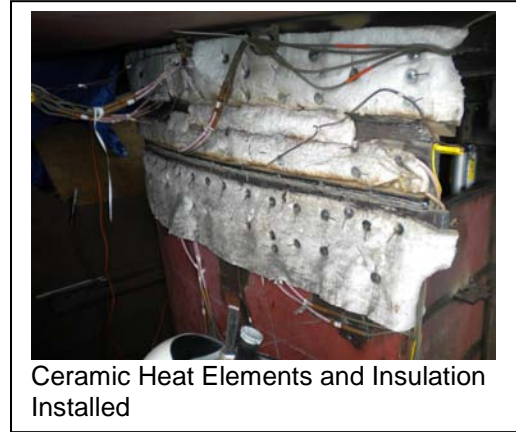
Ceramic Heat Elements and Insulation Installed

After the alignment of the inserts was confirmed, ceramic heating elements and insulation pads were installed, to maintain the pre-heat temperature and to reduce the cooling rate of the finished welds.

After approximately two hours the preheat temperature of 225°F was achieved and the root could be welded. Preheat and minimum interpass temperatures were maintained during the welding operation for a distance not less than 3 in. [75 mm]) in all directions from the point of welding.

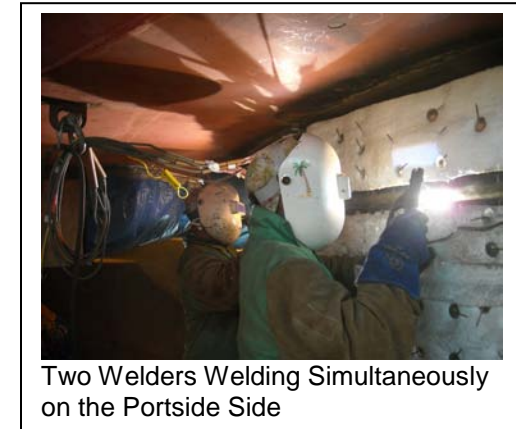
Two Welders Welding Simultaneously on the Portside Side

The two upper joints on the port and starboard side were welded first. The root passes on the upper weld seams were welded simultaneously by one welder on each side, welding in a predetermined welding sequence, starting from the center to the outside. Fill and cover passes were then welded by four welders at the same time, 2 on each side. Welding in two 12 hour shifts.

The welders started in the center of the joint, moving outwards. The challenge was to convince welders it was not a race and each welder had to weld at the same speed. It took 35 passes and approximately 24 hours to fill each of the 12 foot long joints.
