# Rudder and Rudder Horn Repair on the Bulk Freighter Sophia D

By Uwe W. Aschemeier and Kevin S. Peters

On January 21, 2009 the 56,000 t Bulk Carrier Sophia D was in route to China, loaded with thousands of tons of iron ore. Off the coast of Brazil, the ship run on ground, damaging the rudder so severely that the vessel was dead in the water, unable to steer.

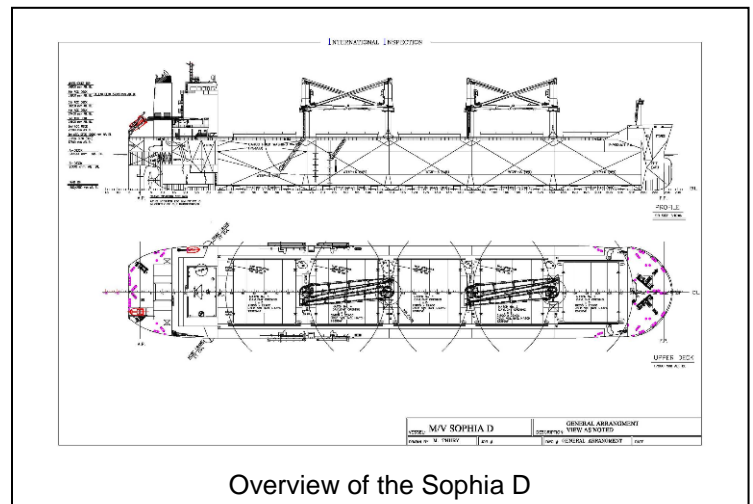
Overview of the Sophia D

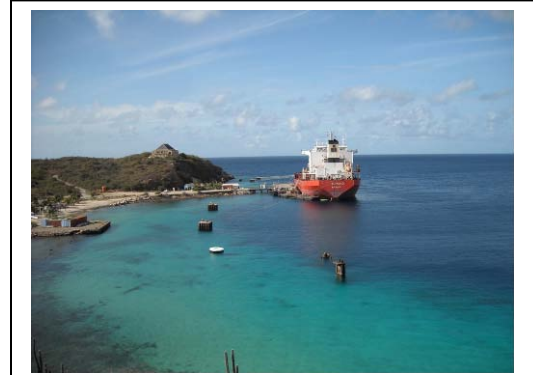
Sophia D in the Caracas Bay

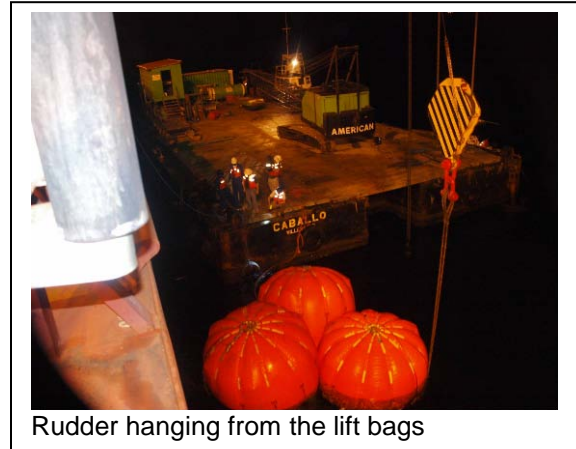
The underwater removal of the rudder was featured on the National Geographic Channel in a show called "The Worlds Toughest Fixes"

The freed rudder blade was lowered on the four air hoists and transferred aft to 70 tons Lift bags. The rudder blade was towed to the backboard side of the ship and a preset rigging was attached to perform a two crane pick using two of the ship's 35 ton cargo cranes. The rudder blade was loaded onto the barge and brought to the ship yard.

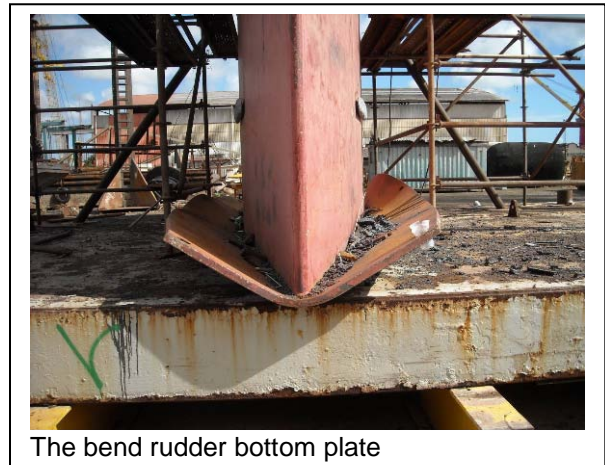
- The upper and lower castings on rudder blade were misaligned
- The 1.75 inches thick rudder bottom plate was bent upwards up to an angle of 45°.
- The skin plates on the port and starboard side as well as the top plate were buckled.
- After the skin plates on the port and starboard side were cropped out to be renewed, internal plates were found to be buckled to a point that they needed to be cropped out and replaced.

The plate mounted to the bottom of the rudder (1 ¾ ") was bent so badly, it had to be trimmed approx. 1" overlapping the edge of the rudder skin, before the rudder could be re-installed onto the vessel. This plate will be replaced later in the ship yard. The purpose of this plate is to help with the steering of the vessel at slow speeds.

After all welding was complete on the new installed insert plates on the port and starboard side, internal plates and the top plate, 100% visual inspection was performed on all welds. All complete joint penetration welds were ultra sonically

After the repairs to the internal frames and the skin plate, the upper and lower hydraulic taper for the rudder stock and pintle had to be line bored.

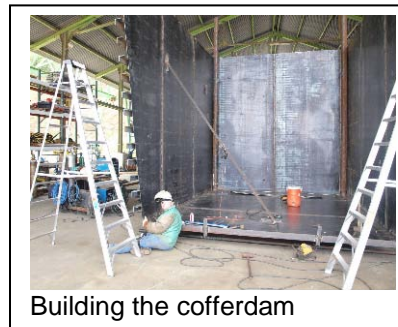
The cofferdam was built while the vessel was being towed from Brazil to Curacao.

A Cofferdam displacing 130 cubic yards of water was engineered by a marine engineer specifically for this job, to be installed around the rudder horn, once the rudder was removed. The 23,000 pound cofferdam was built in facilities of Miami Diver in Curacao. The approximately 15 feet long, 13 feet wide, and 14 feet tall cofferdam was built out of ¼” (6.35 mm) thick ASTM A36, reinforced with 4X4X3/8 angles at the bottom and the side walls.
